# GEOTECHNICAL INVESTIGATION OUTENIQUASBOSCH PHASE 9, HARTENBOS

## TEST PIT 2 : PROFILE

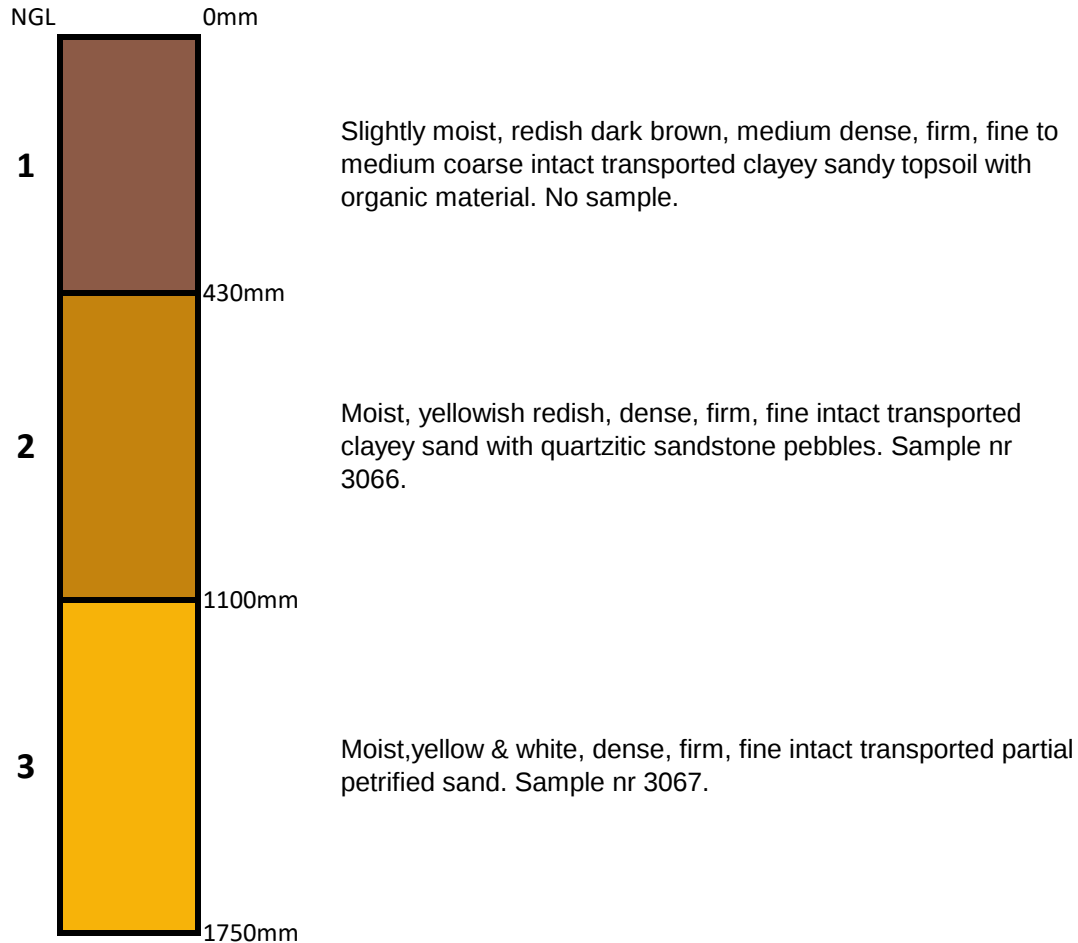
No seepage water was observed.  
No refusal in test pit.  
Excavation method : Tracked Excavator  
Date of excavation : 18 September 2023
