# GEOTECHNICAL INVESTIGATION OUTENIQUASBOSCH PHASE 9, HARTENBOS

## TEST PIT 6 : PROFILE

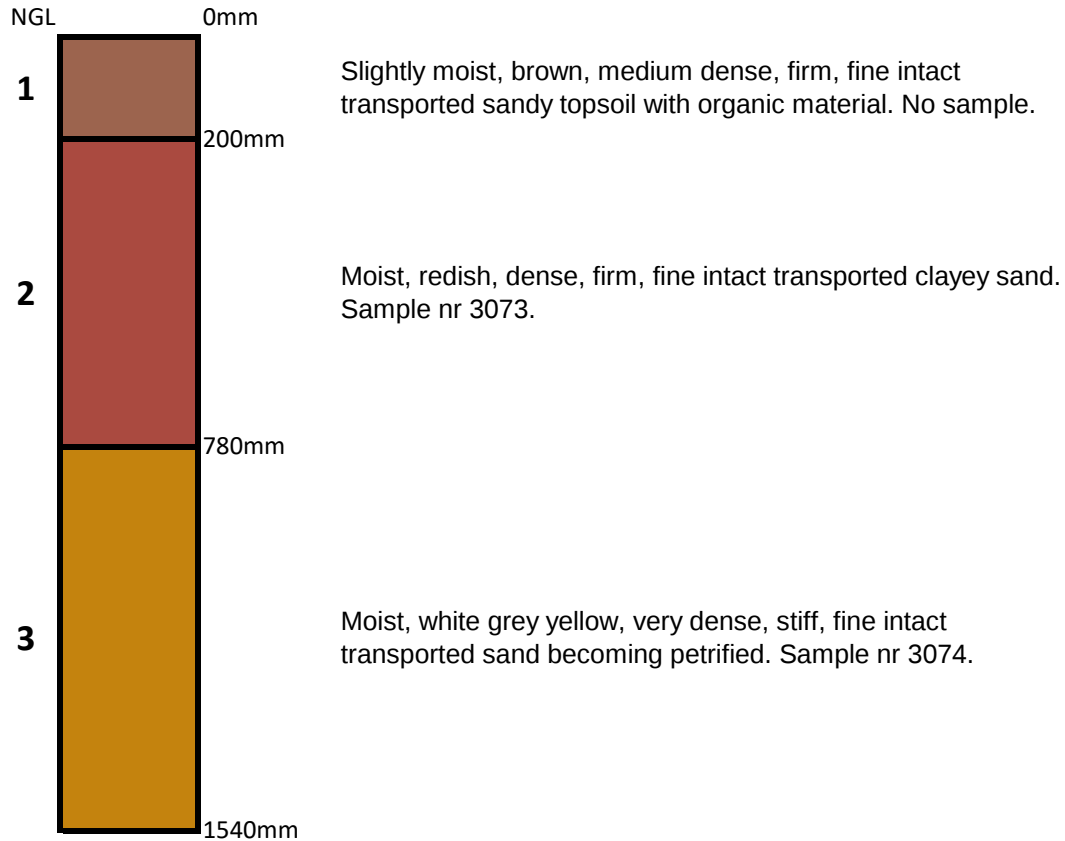
No seepage water was observed.  
Partially refusal at NGL -1540mm.  
Excavation method : Tracked Excavator  
Date of excavation : 18 September 2023
