# GEOTECHNICAL INVESTIGATION

## OUTENIQUASBOSCH PHASE 11 & 13, HARTENBOS

### TEST PIT 2 : PROFILE

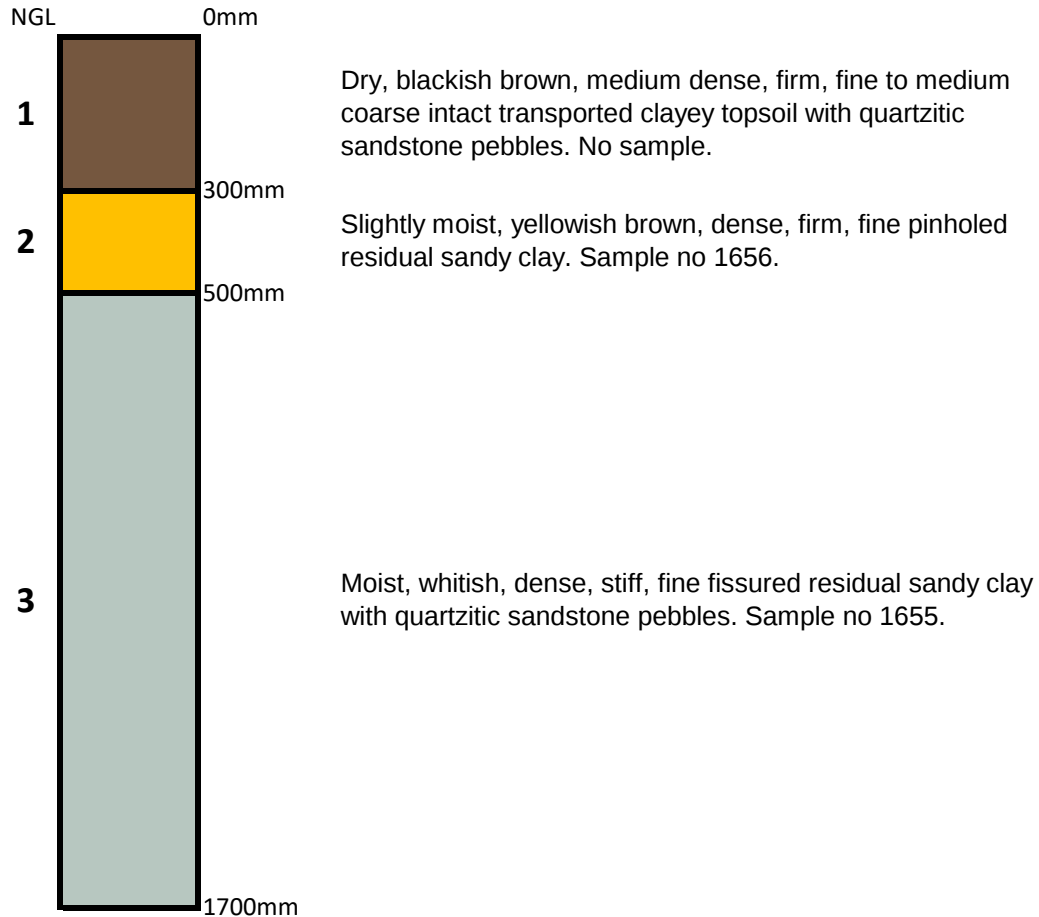
No seepage water was observed.  
No refusal in test.  
Excavation method : Digger Loader  
Date of excavation : 27 April 2022
