# GEOTECHNICAL INVESTIGATION OUTENIQUASBOSCH PHASE 4, HARTENBOS

## TEST PIT 3 : PROFILE

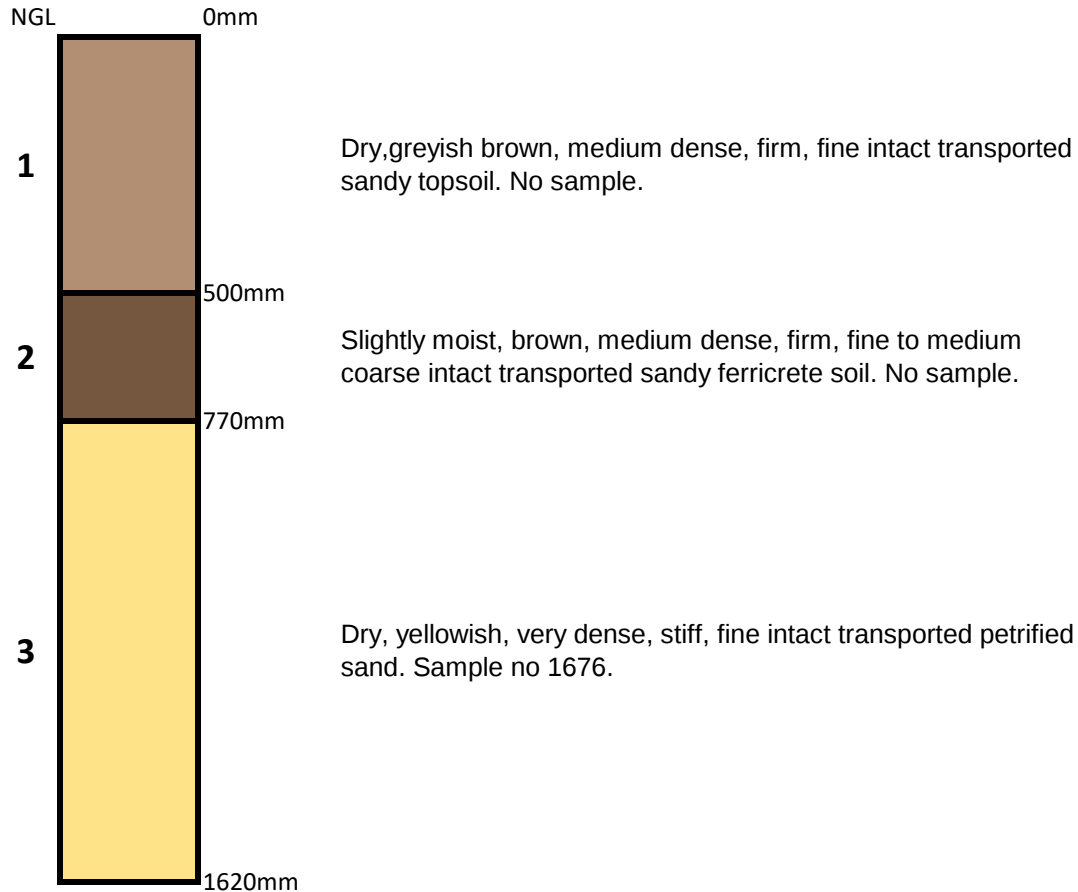
No seepage water was observed.  
Partial refusal in test pit at NGL -1620mm.  
Excavation method : Digger Loader  
Date of excavation : 4 May 2022
