# GEOTECHNICAL INVESTIGATION OUTENIKUASBOSCH PHASE 7, HARTENBOS

## TEST PIT 3 : PROFILE

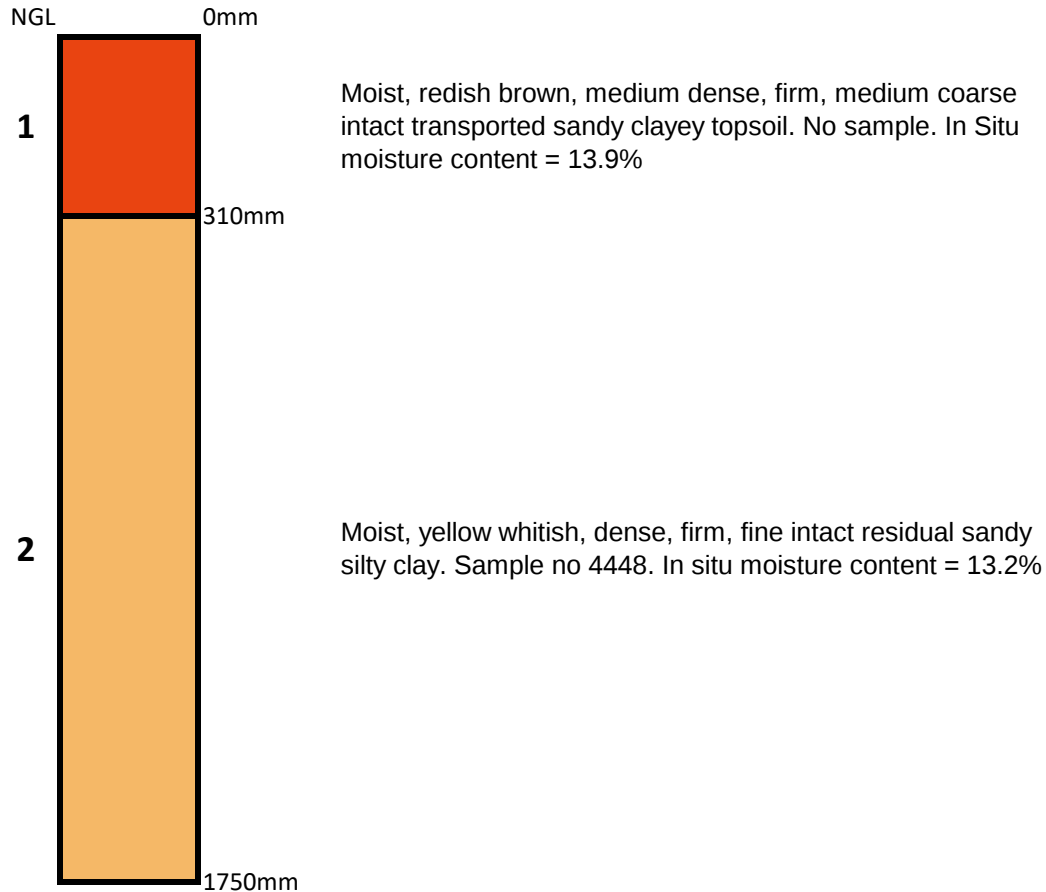
No seepage water was observed.  
No refusal in test pit.  
Excavation method : Tracked excavator  
Date of excavation : 4 February 2025
