# DEVELOPMENT OF THE FARM OUTENIKUASBOSCH 149 AND PART 10 & 28 OF THE FARM HARTENBOSCH 217

## TEST PIT J

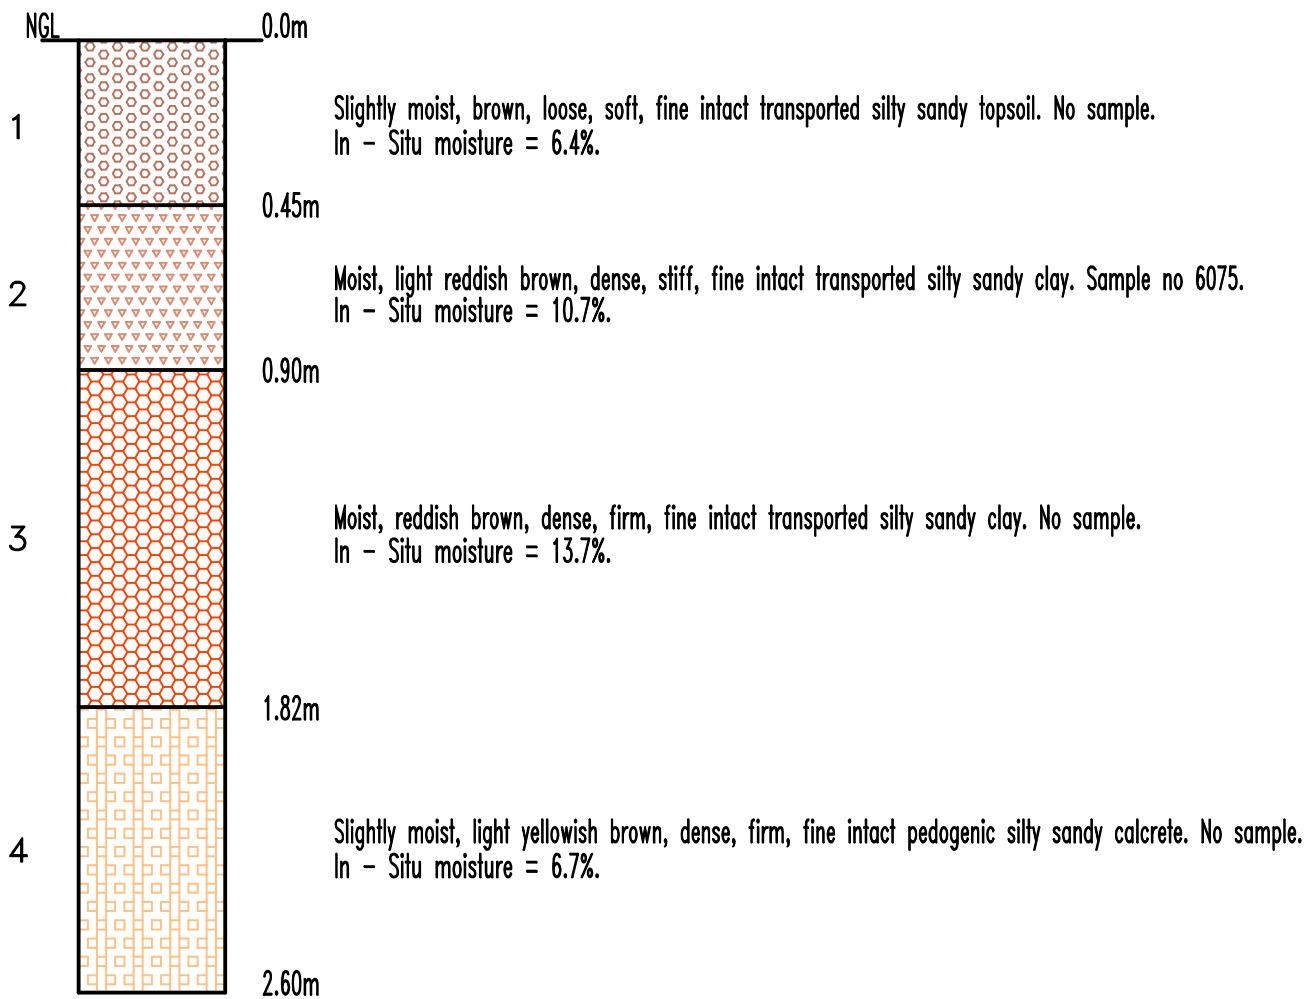
No seepage water was observed.  
No refusal in test pit.  
Excavation method : CAT digger loader.  
Date of excavation : 05 October 2018.
