### SOIL ANALYSIS TEST REPORT

| Project Information: | Phase 12 & 14 Outeniquasbosch | |
| Source of sample | Test Pit 1 (Phase 12) | |
| Material description: | Reddish Brown Orange Sandy Clay | |

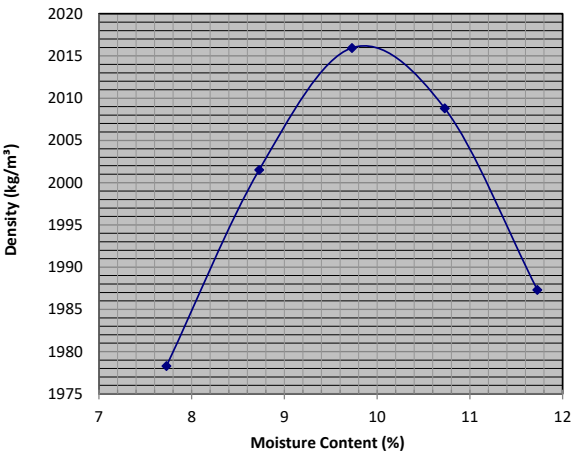
| <b>TESTPRO LABORATORY</b><br>Materials Testing Laboratory | | | | <b>sanas</b><br>Testing Laboratory<br>10552 | | | | | | | |
|---|---|---|---|---|---|---|---|--|--|--|--|
| Material Description | Reddish Brown Orange Sandy Clay | | | GRADING | | G9 | | | | | |
| Source | Test Pit 1 (Phase 12) | Position/ Layer | Layer 2 | Sieve Size | % Passing | Specifications | Uncertainty | | | | |
| Date Received | 23/01/2023 | Date Tested | 31/01/2023 | 75 | 100 | | Opinion | | | | |
| Sampling Method | TMH5:MA2 | Sample Number | 2371 | 63 | 100 | | ✓ or X | | | | |
| MDD | 2016 | kg/m³ | OMC | 37.5 | 100 | | | | | | |
| Method | Scalped | % Scalped | 0,8 | 14 | 97 | | | | | | |
| Uncertainty | | | | 5 | 96 | | | | | | |
| MDD | | kg/m³ | OMC | 2 | 96 | | | | | | |

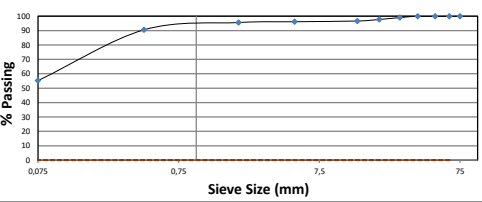
| <b>TESTPRO LABORATORY</b><br>Materials Testing Laboratory | | | | <b>sanas</b><br>Testing Laboratory<br>10552 | | | | | | | |
|---|---|---|---|---|---|---|---|--|--|--|--|
| | | | | Test | Results | Specifications | Opinion | | | | |
| | | | | Grading Modulus | 0,6 | 0.75<2.7 | ✗ | | | | |

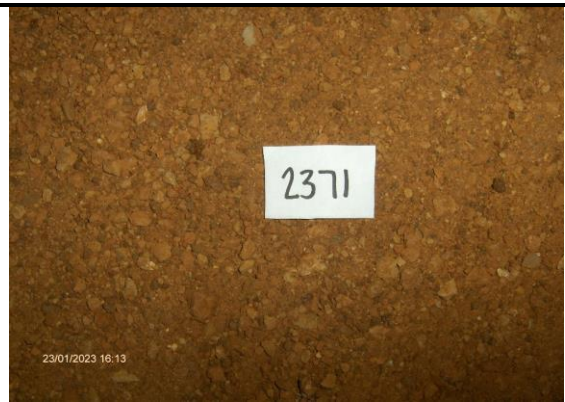
| <b>TESTPRO LABORATORY</b><br>Materials Testing Laboratory | | | | <b>sanas</b><br>Testing Laboratory<br>10552 | | | | | | | |
|---|---|---|---|---|---|---|---|--|--|--|--|
| | | | | CBR | | | | | | | |
| | | | | Moulding MC% | 9,7 | | | | | | |
| | | | | CBR @ 98% | 4 | | | | | | |
| | | | | CBR @ 97% | 4 | | | | | | |
| | | | | CBR @ 95% | 3 | | | | | | |
| | | | | CBR @ 93% | 3 | Min 7 | ✗ | | | | |
| | | | | CBR @ 90% | 2 | | | | | | |
| | | | | Swell @ 100% | 1,8 | Swell<1.5% | ✗ | | | | |
