# GEOTECHNICAL INVESTIGATION

## OUTENIKUASBOSCH PHASE 12 & 14, HARTENBOS

### TEST PIT 1 (PHASE 12): PROFILE

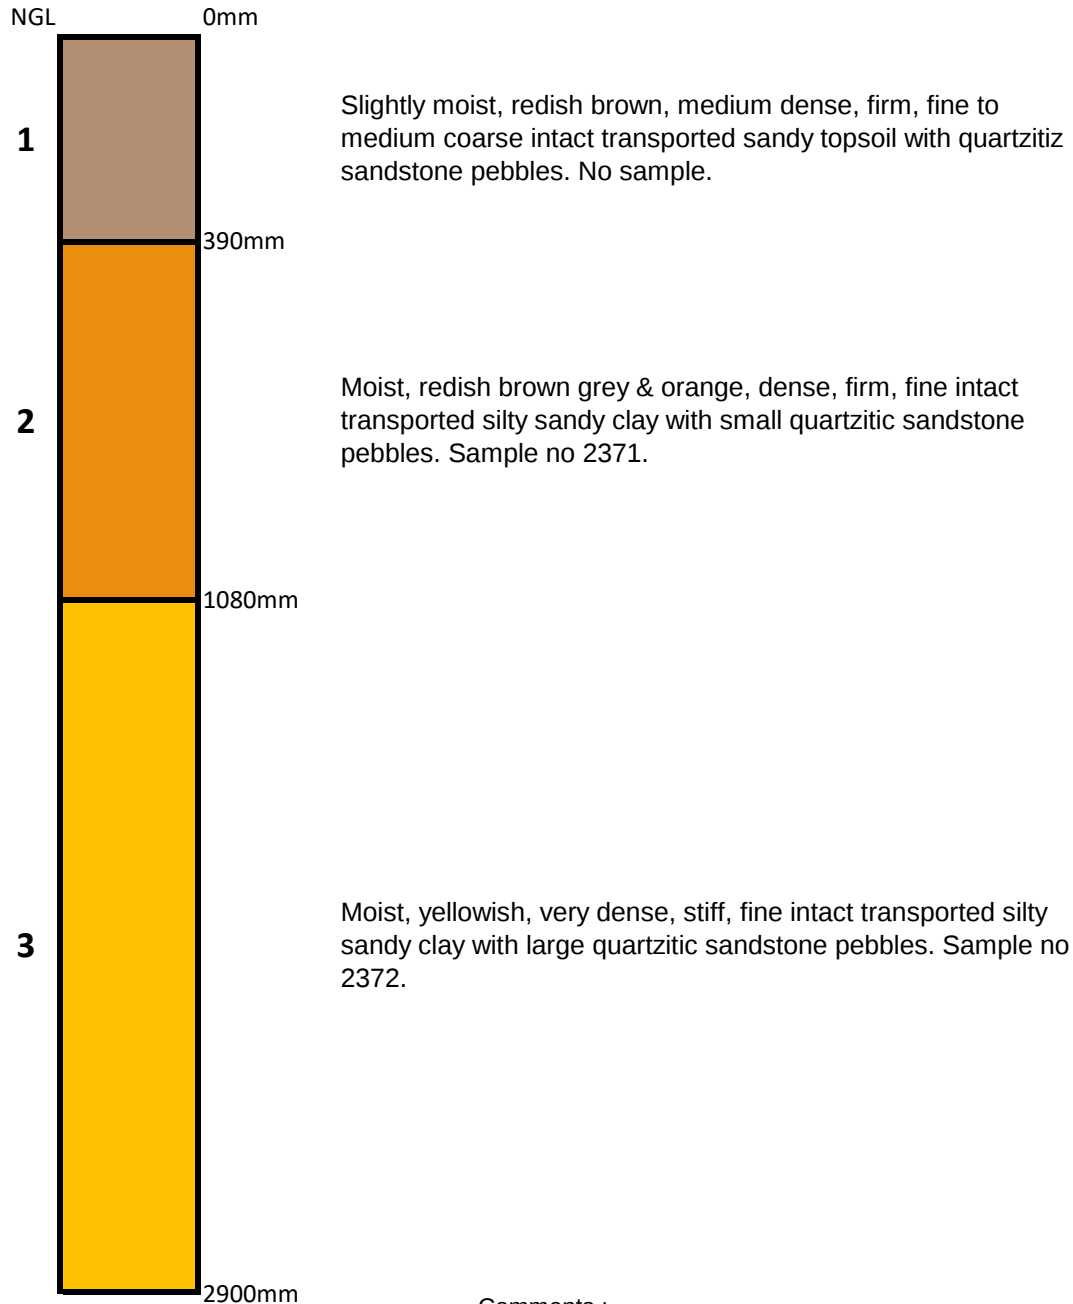
No seepage water was observed.  
No refusal in test.  
Excavation method : Tracked Excavator  
Date of excavation : 23 January 2023
