# GEOTECHNICAL INVESTIGATION OUTENIQUASBOSCH PHASE 12 & 14, HARTENBOS

## TEST PIT 3 (PHASE 14): PROFILE

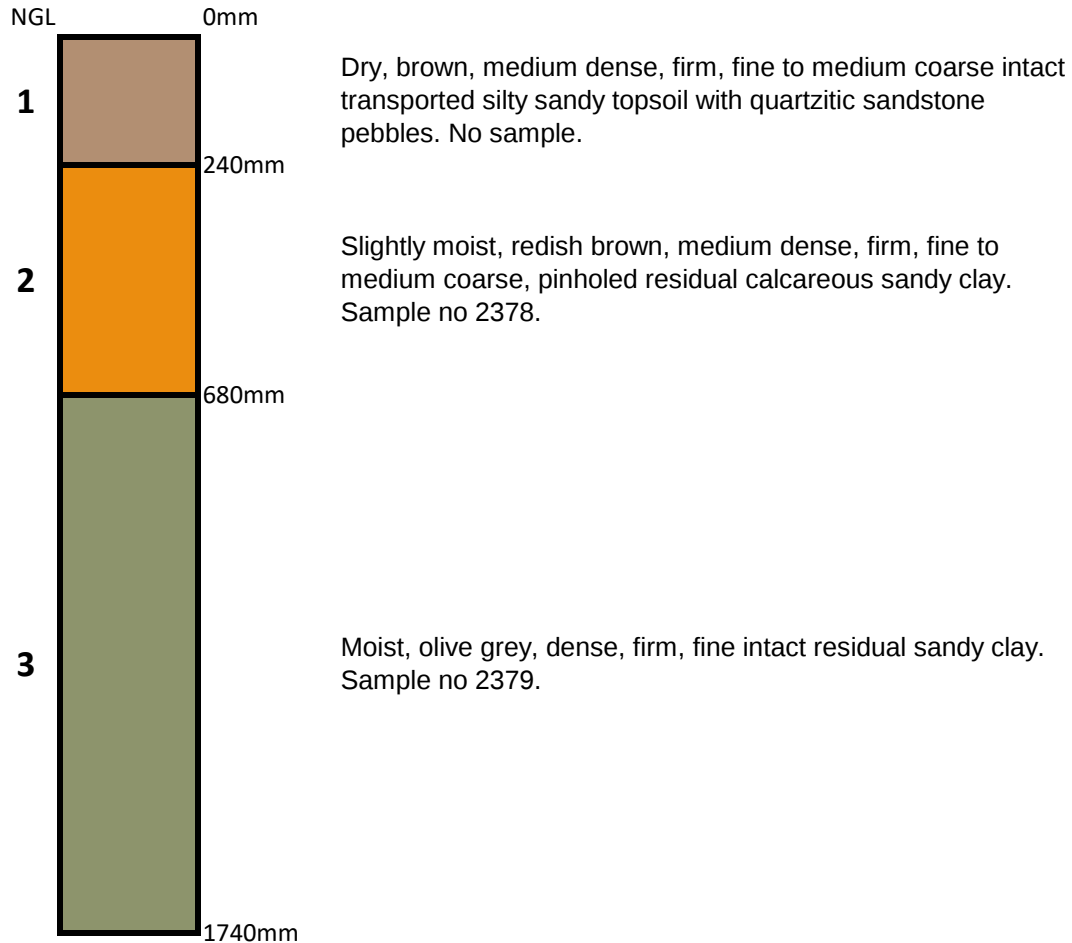
No seepage water was observed.

No refusal in test.

Excavation method : Tracked Excavator

Date of excavation : 25 January 2023
