# GEOTECHNICAL INVESTIGATION OUTENIQUASBOSCH PHASE 9, HARTENBOS

## TEST PIT 5 : PROFILE

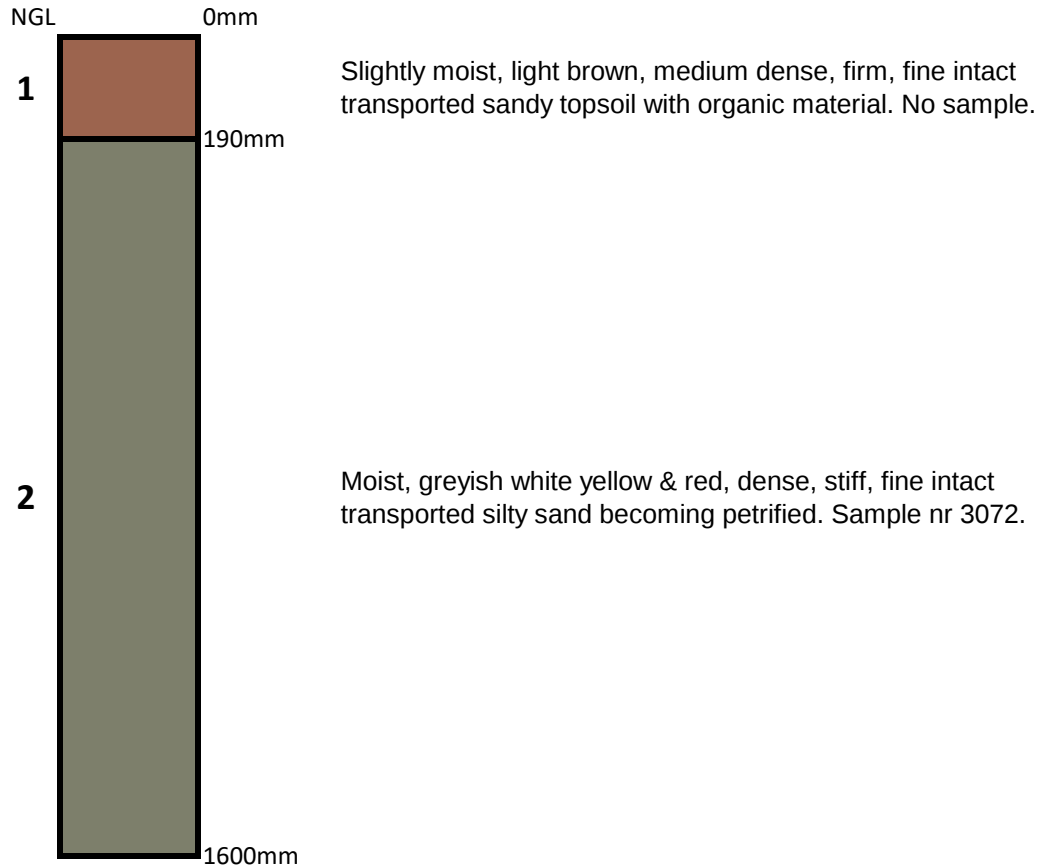
No seepage water was observed.  
Partially refusal at NGL -1600mm  
Excavation method : Tracked Excavator  
Date of excavation : 18 September 2023
