# GEOTECHNICAL INVESTIGATION OUTENIQUASBOSCH PHASE 11 & 13, HARTENBOS

## TEST PIT 5 : PROFILE

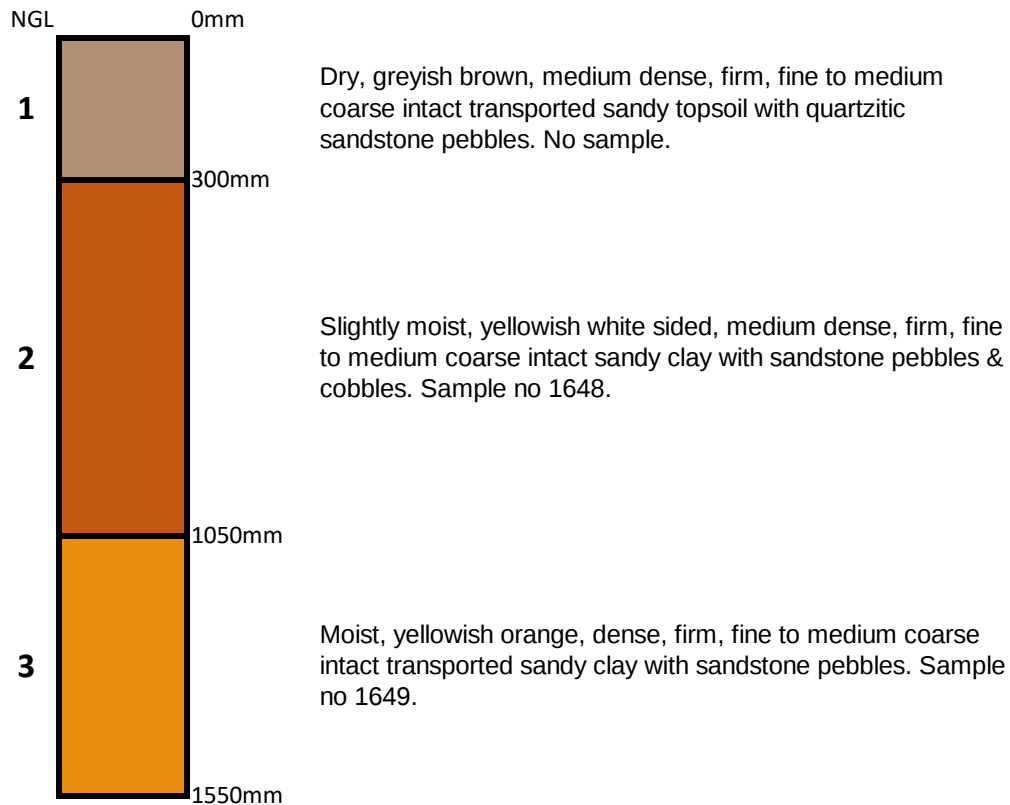
No seepage water was observed.  
No refusal in test pit.  
Excavation method : Digger Loader  
Date of excavation : 27 April 2022
