# GEOTECHNICAL INVESTIGATION OUTENIQUASBOSCH PHASE 4, HARTENBOS

## TEST PIT 4 : PROFILE

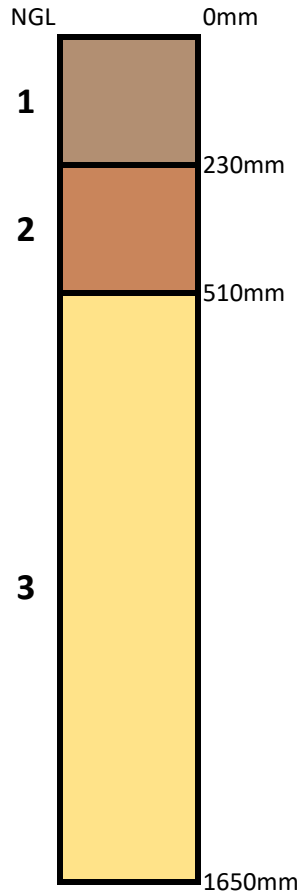
No seepage water was observed.  
Partial refusal in test pit at NGL -1650mm.  
Excavation method : Digger Loader  
Date of excavation : 4 May 2022
