# GEOTECHNICAL INVESTIGATION OUTENIKUASBOSCH PHASE 7, HARTENBOS

## TEST PIT 5 : PROFILE

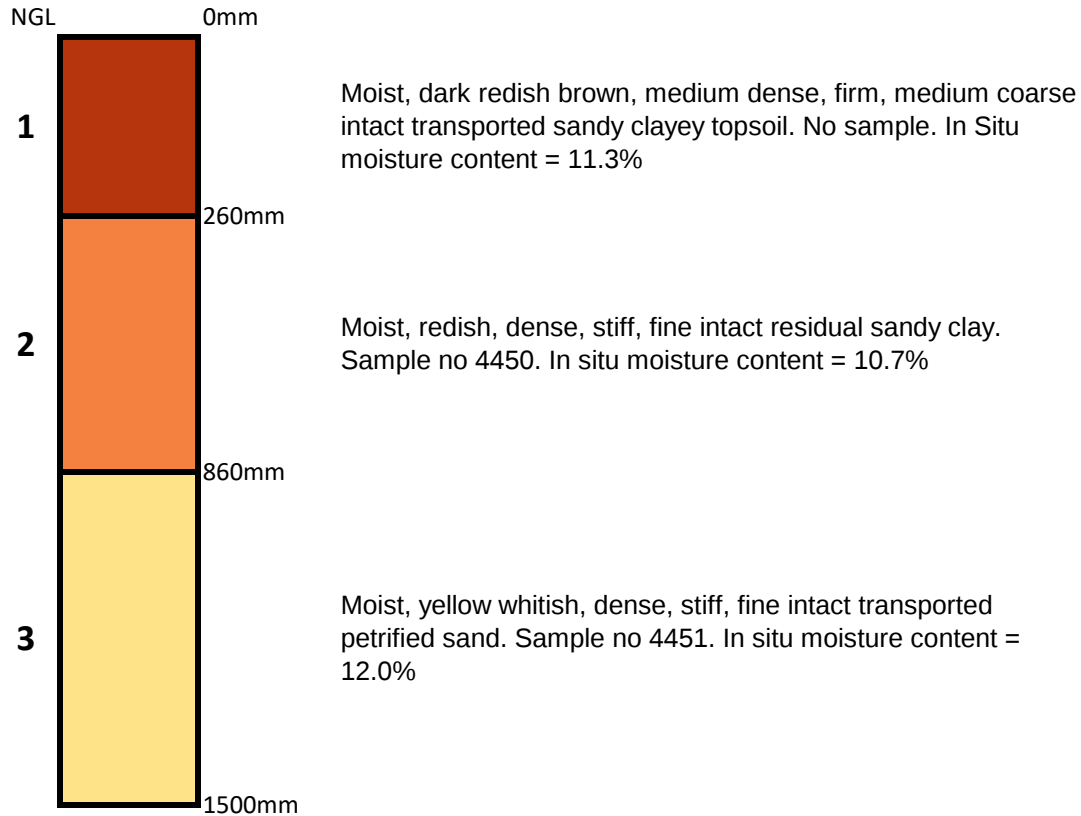
No seepage water was observed.  
No refusal in test pit.  
Excavation method : Tracked excavator  
Date of excavation : 4 February 2025
